Project Title: Positive Guidance Demonstration Project

Project No: E-20-603

The purpose of this demonstration project is to utilize the Positive-Guidance procedure to analyze a railroad-highway at-grade crossing with apparent motorist-information deficiencies; determine and implement solutions; and evaluate the effectiveness of both the solutions and the Positive Guidance procedure.

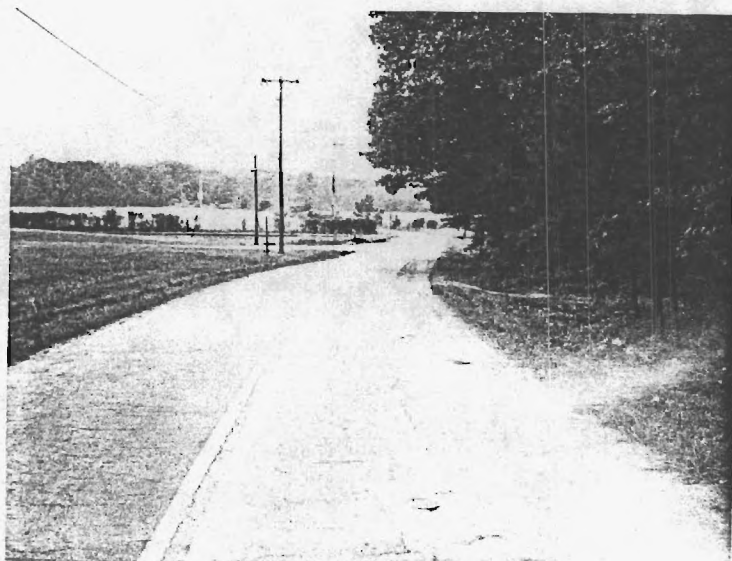
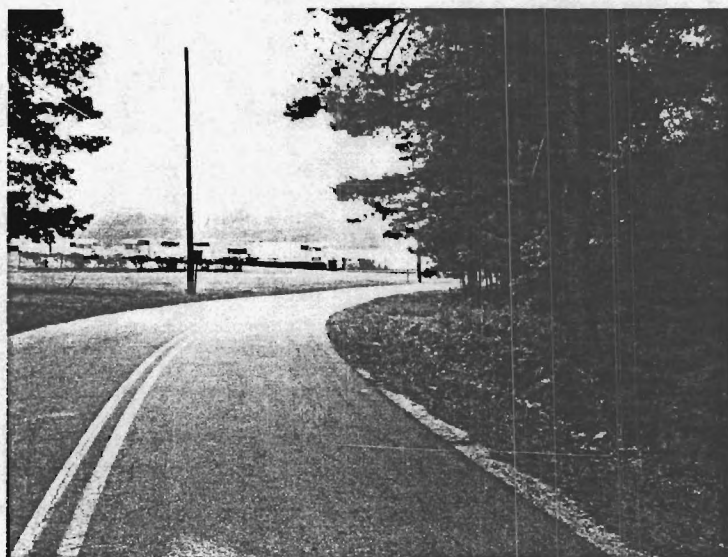
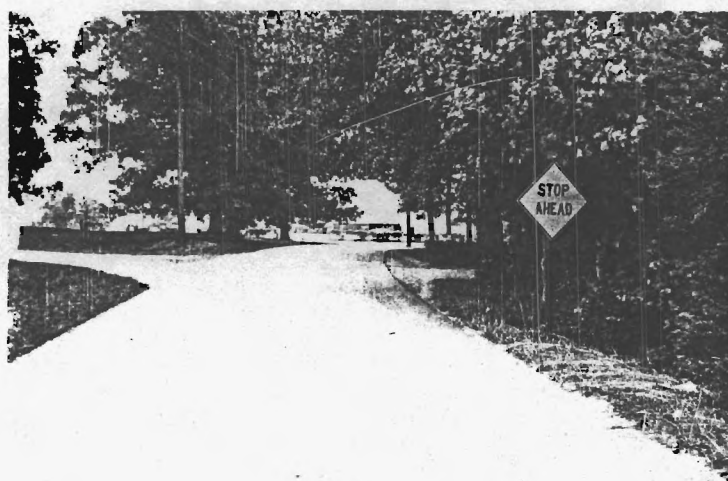
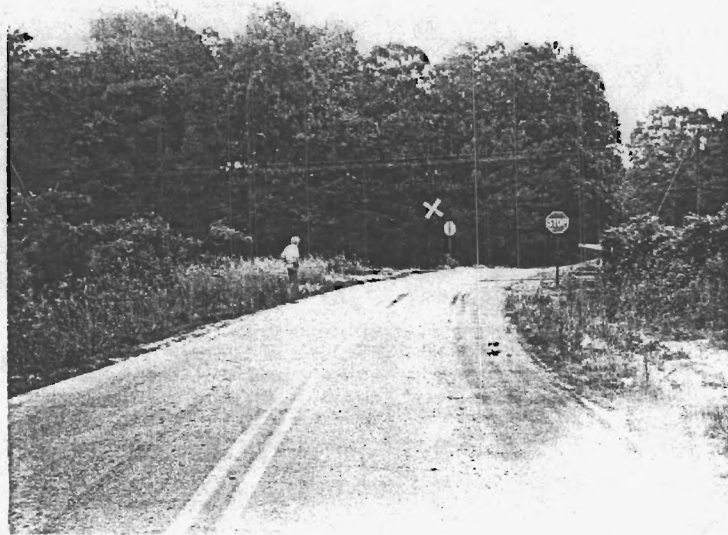
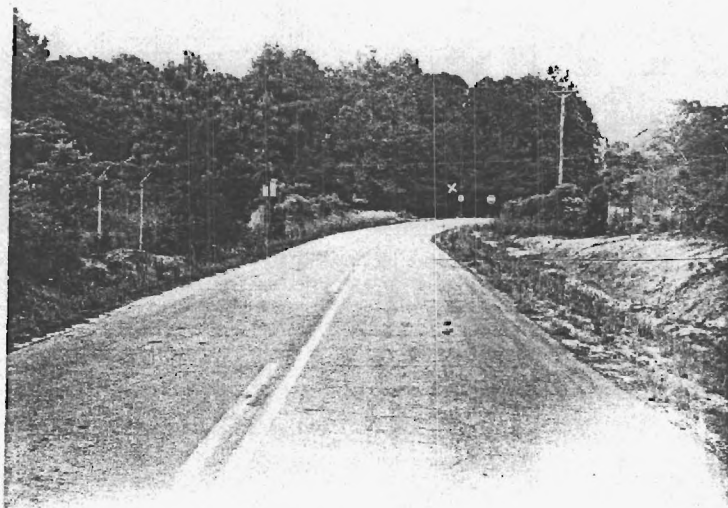
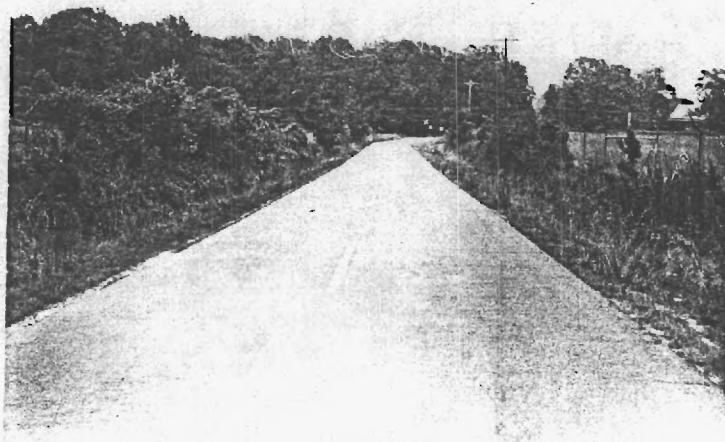
Figure 2. Photos of site in Level 1 (as-is) condition

2 a. Approach From Northeast, 150 feet From Track
Sign at Far Right, '110' Back, says GEORGIA LAW, STOP, UNSAFE RR CROSSING

2 b. Approach From Northeast, 300 feet From Track

2 c.. Approach From Northeast, 450 feet From Track

2 d.. Approach From Northeast, 600 feet From Track

2 e. Approach from Southwest, 140 feet From Track

2 f. Approach from Southwest, 140 feet From Track

2 g. Approach From Southwest, 300 feet From Track

2 h. Approach From Southwest, 600 feet From Track

Site Survey (Drive-Through). Motion pictures (16 mm), color slides, and black-and-white prints were obtained over 1000 feet of each approach, for both the Level 1 (as-is) condition and the Level 2 condition (Upgraded to MUTCD standards). Figures 6 and 7 show to scale the details of the markings and signs for these two levels. Figure 8 is a collection of photographs taken after upgrading the site to MUTCD standards.

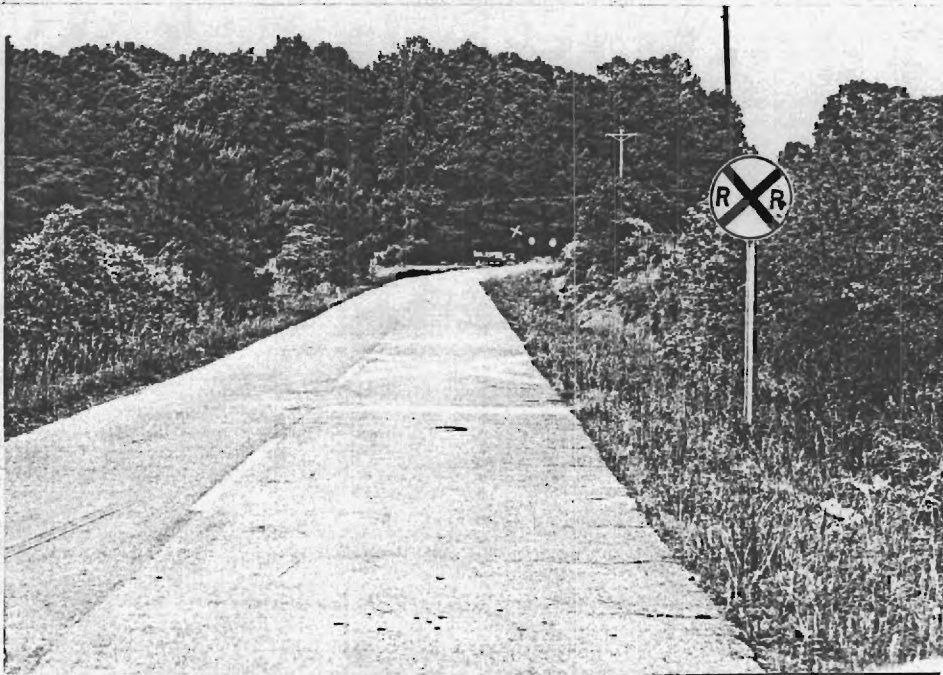
Figure 8. Photos of site in Level 2 condition (upgraded to MUTCD standards)

8 a. Crossbuck sign and markings 435 feet from crossing (eastbound traffic on west approach).

8 b. STOP AHEAD sign 870 feet from crossing (Eastbound traffic on west approach).

8 c. Crossbuck sign and markings 335 feet from crossing (westbound traffic on east approach)

8 d. STOP AHEAD sign 555 feet from crossing (westbound traffic on east approach)

Since the upgrading to the MUTCD, the Level 2 condition, eastbound drivers now encounter a STOP AHEAD sign 870 feet from the track, plus a crossbuck sign and pavement marking 435 feet from the crossing. On the other approach, westbound drivers now find a crossbuck sign and marking 335 feet from the track. Also, their STOP AHEAD sign has been upgraded to the early version of the

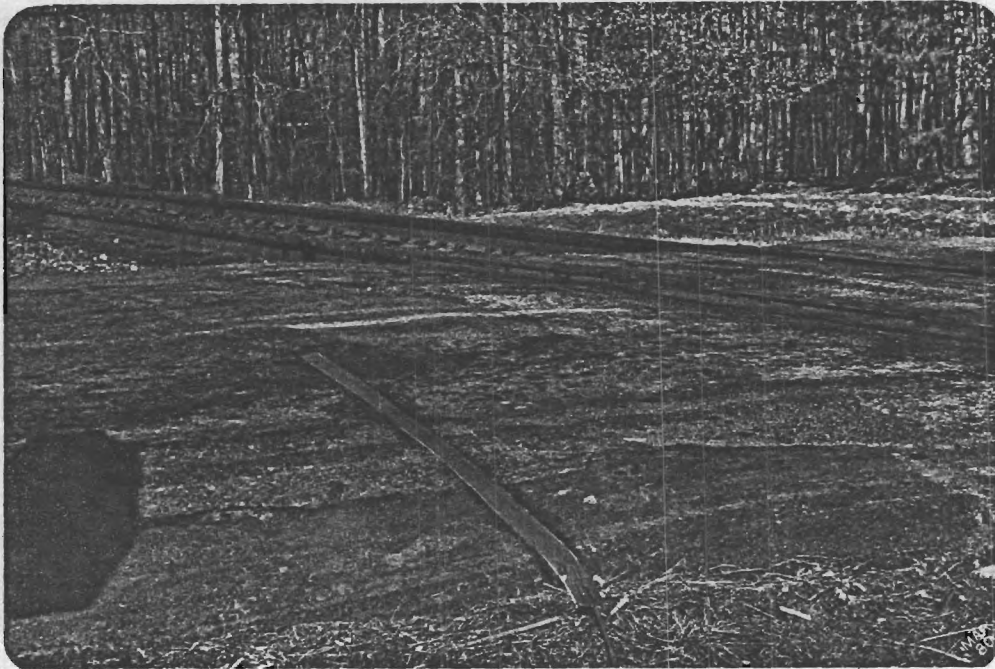
Figure 14. Tapeswitches in place on Stanley Road

Figure 14 and 15 show the tapeswitches and microprocessor, respectively. The drive-through movie for the Level 2 condition also shows the tapeswitches, and indicates that they are all but invisible to the motorist at speed. They are less than 3/16 inch thick, including the layers of tape, and are quite silent and unobtrusive. Figure 14 makes it clear that they are quite visible to a slow driver close to the track. Ignored by motorists during level 1 and 2 evaluations, the tapeswitches became a target for vandals after the Positive Guidance solution was installed.

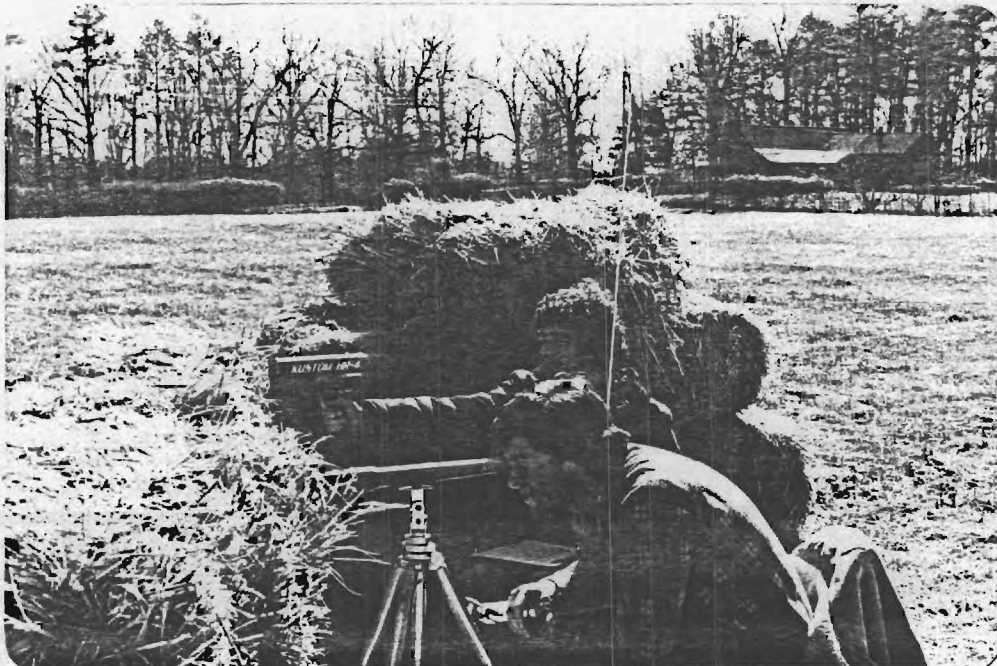
Figure 16. Collection of data on looking behavior and (radar) speed

16 a. Observations of westbound traffic in early stage of project. Stanley Road lies beyond the bushes and home in background.

16 b. Station is inobtrusive from Stanley Road.

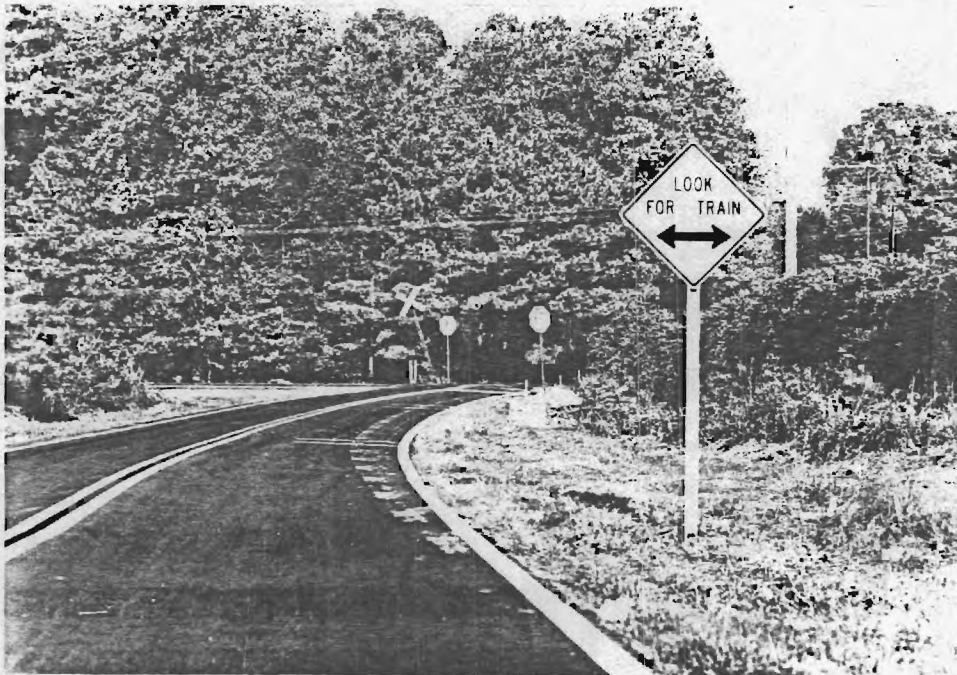
Figure 20. Photos of site in level 3 condition (Positive Guidance)

Figure 20 is a set of photos showing all of the Positive Guidance signs and two of the rumble strips. The photos also reveal that Stanley Road was resurfaced and restriped by the County prior to the Positive Guidance installation. The photos of Figure 8, earlier in this report, showed that, prior to the repaving both approaches were quite smooth and merely had some transverse and longitudinal cracking. The project staff is of the opinion that the resurfacing would not significantly increase speeds on these approaches.

20a. LOOK FOR TRAIN sign 150 feet from crossing (eastbound traffic on west approach). Sign on ground in background was placed by a candidate for election.

20b. HIDDEN XING sign below RR crossbuck sign, eastbound direction, 435 feet from crossing, partially obscured by bush. Note rumble strip in foreground, pair of tapeswitches beyond.

20c. Late afternoon sun emphasizes a rumble strip on the westbound approach, 655 feet from crossing.

20d. Diagrammatic left-turn railroad crossing sign on the access road next to the track.

Unlike the experience of levels 1 and 2, it was found in the level 3 evaluation that the tapeswitches and their wires were a target for vandals. Figure 20 shows that the tapeswitches are especially visible in an afternoon sun. Almost every day a tapeswitch was taken up, or wires disconnected or removed. The data were gathered as quickly as possible, to minimize exposure. During the last two days a guard was posted all day to see that the installation was not vandalized. The main concern was that vandals might follow the wires into the woods to the tent sheltering the microprocessor and peripheral equipment.
